Location Name	Maisemore Gardens	Coastal Policy Unit	5a16
Report Date	08/12/2022	Coastal Policy	HTL – Hold the Line
Landowner	Private (unknown)	MWF Lot	Lot 1
Maintainer	Private (Maisemore Gardens Ltd) (Seawall only)	Assets at Risk	Residential properties, gardens, coastal footpath
Report By	Amy Smith	Asset Overall Condition	Fair
Structure Reference	Asset475	Worst Element Condition	Poor (at western end of wall and coastal footpath)
Structure Type	Seawall and raised footpath	Report Reference	AIN_HBC_20221102
Structure Description	Concrete seawall constructed in 1960's protecting properties, with raised footpath running along the front face fronted with blockwork. Raised footpath – unknown owner & maintainer	Defect co-ordinates	473974.351; 105366.383
Erosion Risk	Yes/No (structures)	Flood Risk	Yes/No (occasionally flooded raised footpath at particularly high tides, no record of flooded homes/gardens)

Inspection Summary

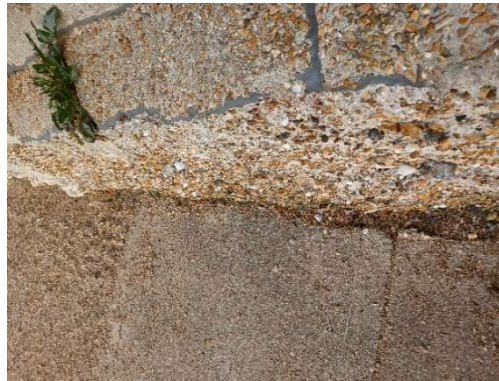
Plate 1: Spalling of concrete on seawall

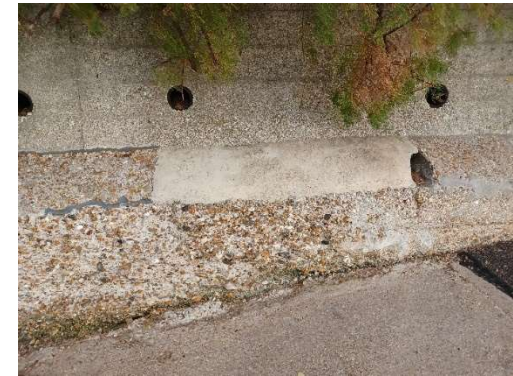
Plate 2: Face of seawall with drainage channels

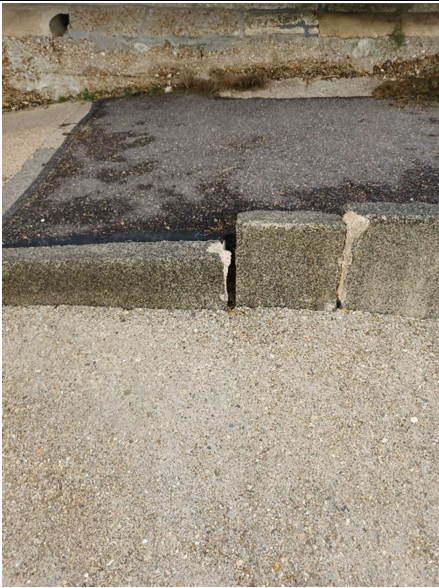
- No significant changes since last inspection:
 - Some damaged noted to capping stones at edge of raised footpath – suspected undermining (Plate 3)
 - Seawall in fair condition along majority of the length. Some vegetation growth identified over the wall – from the visual inspection this does not appear to be causing damage to the structure.

Plate 3: damaged capping stones at edge of footpath

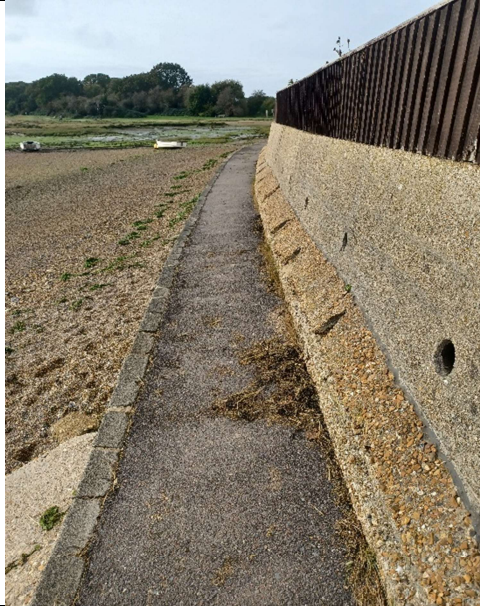
- The coastal raised footpath is in a fair condition, with no damage identified to tarmac surface. (Plate 4)
 - Some undermining noted to the seaward side of the footpath ramp on to the foreshore. Maintenance may be required to this section of footpath in the future.

Plate 4: surface of footpath remains in good condition

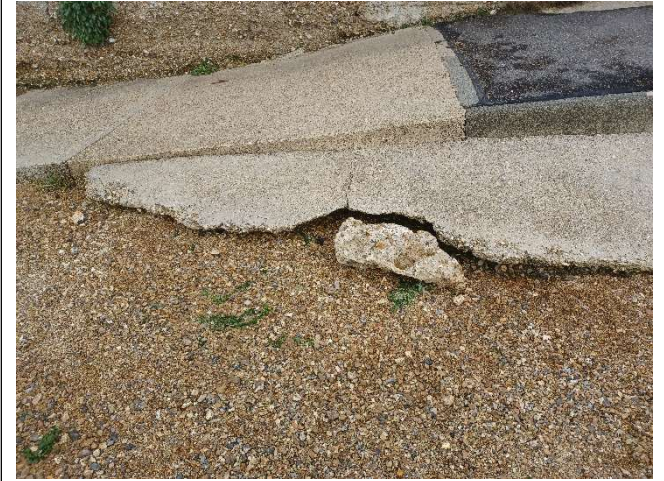
Plate 5: western end of seawall – ramp meets the foreshore – historical repair now undermined

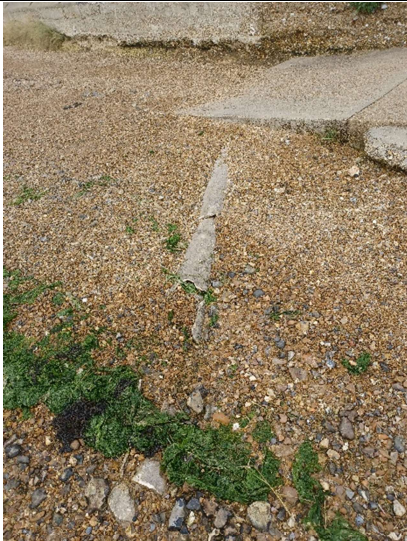
Plate 6: exposed concrete pipe	Plate 7: vegetation and drainage holes over seawall	Plate 8: eastern end of seawall

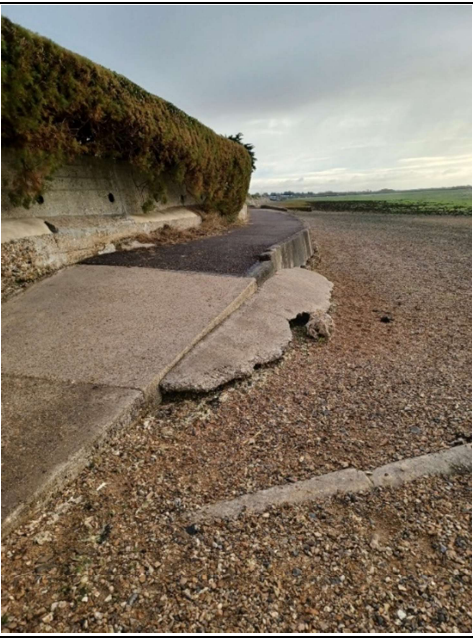
Plate 9: undermining of concrete toe on footpath	Plate 10: undermining of seawall toe	Plate 11: spalling of face and undermining of wall

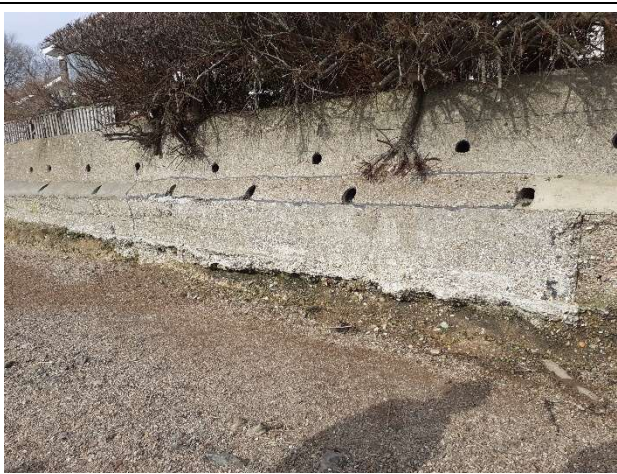
- It appears that the toe of the seawall was originally constructed into the sediment of the foreshore. Lowering foreshore levels have now undermined the structure over a length of 23m - I have concerns that this section of structure is currently just sat on the foreshore with no support from the sediment. Due to the lack of sediment the seawall is at potential risk of rotating seaward. plate 10.

- Continue to monitor the beach levels in front of western end of seawall. Maisemore Garden residents have been carrying out beach monitoring for ~7 years at the western end of the beach.
- If beach levels continue to decrease, consider the movement of small quantities of shingle to fill the void at the edge of the footpath under the concrete slab (plate 9)
- Should the undermining of the seawall continue, consideration should be taken by the owner for remedial options
- Longer term, consider whether the ramp at the end of the footpath needs extending further to reduce the risk of any undermining should beach levels lower

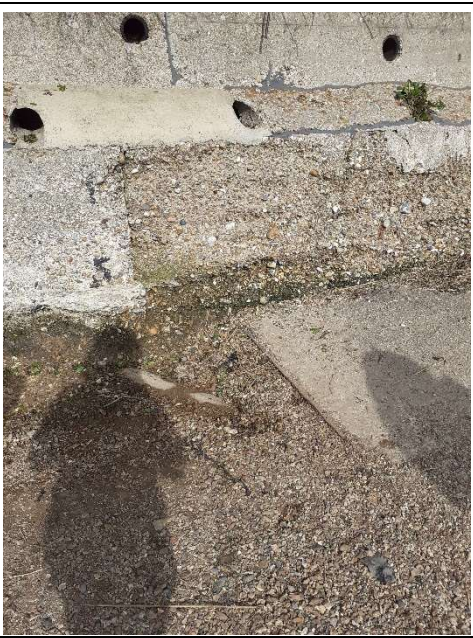
- Some spalling of concrete face of the seawall identified towards the western end of the structure, past the end of the raised footpath (see plate 11), where beach levels have lowered over time. Undermining of the seawall at this location has also been identified –
