Location Name	Maisemore Gardens	Coastal Policy Unit	5a16
Report Date	08/12/2022	Coastal Policy	HTL – Hold the Line
Landowner	Private (unknown)	MWF Lot	Lot 1
Maintainer	Private (Maisemore Gardens Ltd) (Seawall only)	Assets at Risk	Residential properties, gardens, coastal footpath
Report By	Amy Smith	Asset Overall Condition	Fair
Structure Reference	Asset475	Worst Element Condition	Poor (at western end of wall and coastal footpath)
Structure Type	Seawall and raised footpath	Report Reference	AIN_HBC_20221102
Structure Description	Concrete seawall constructed in 1960's protecting properties, with raised footpath running along the front face fronted with blockwork. Raised footpath – unknown owner & maintainer	Defect co-ordinates	473974.351; 105366.383
Erosion Risk	Yes/No (structures)	Flood Risk	Yes/No (occasionally flooded raised footpath at particularly high tides, no record of flooded homes/gardens)

Inspection Summary

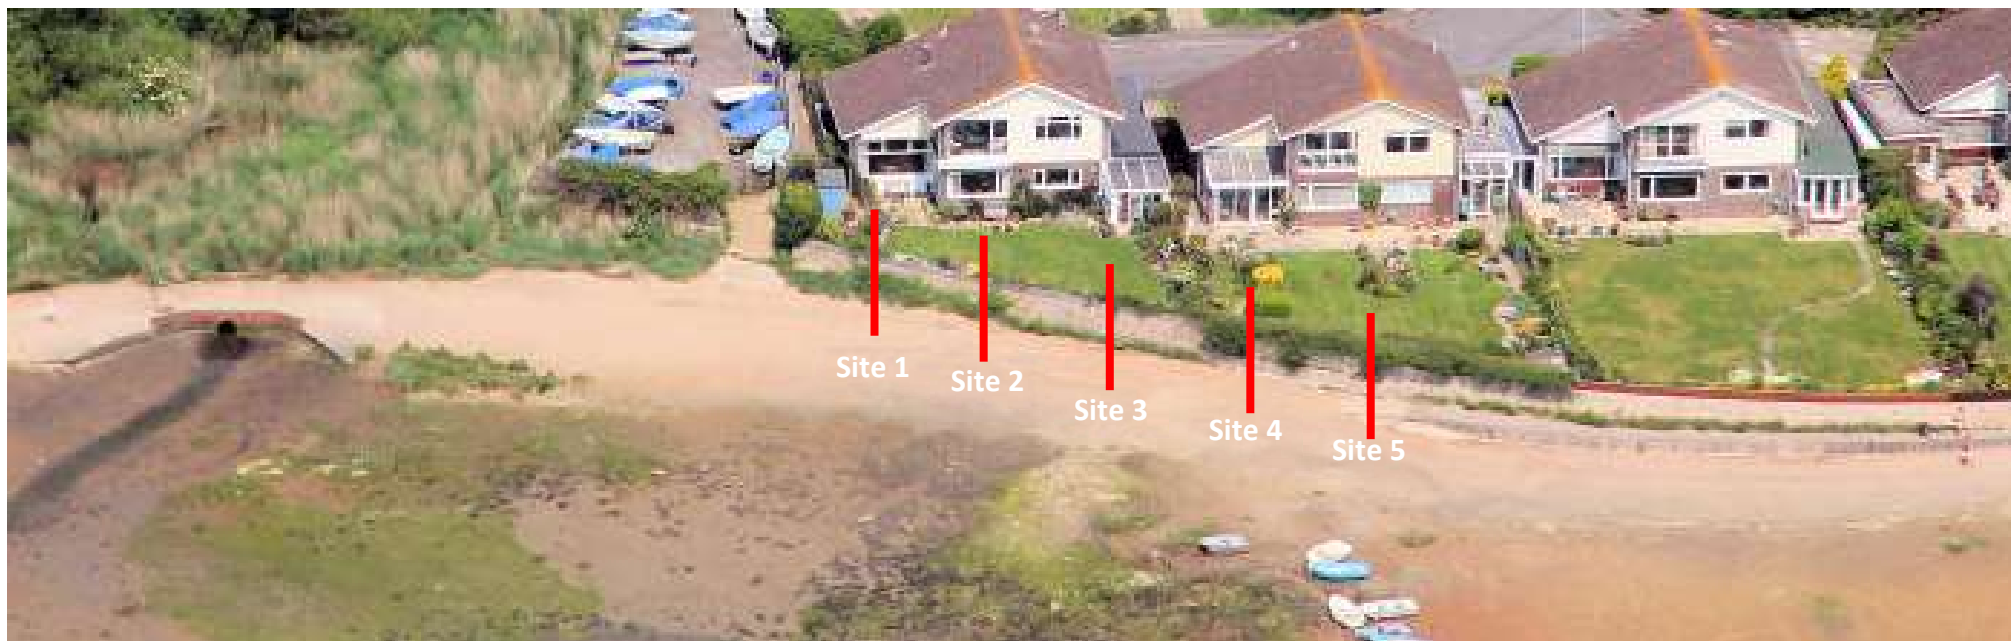
Location of measured data points (site locations approximate), along Maisemore Gardens frontage. Data provided by Maisemore Gardens residents. Photography (www.maisemoregardens.co.uk)

- Continue to monitor the beach levels in front of western end of seawall. Maisemore Garden residents have been carrying out beach monitoring for ~7 years at the western end of the beach.
- If beach levels continue to decrease, consider the movement of small quantities of shingle to fill the void at the edge of the footpath under the concrete slab (plate 9)
- Should the undermining of the seawall continue, consideration should be taken by the owner for remedial options
- Longer term, consider whether the ramp at the end of the footpath needs extending further to reduce the risk of any undermining should beach levels lower
